Software update instruction X-402 v 4.2 ([optional] DAB Firmware)

Instruction for SW v4.2 (OS, APP, MCU and optional DAB Firmware):

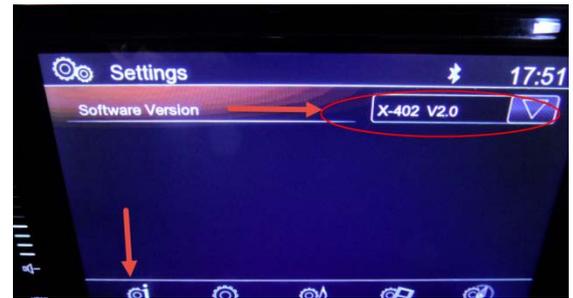
Picture 1: where to find the software version

Main Version: v4.2	
OS T8_1151_190507_02 (ATTENTION if the OS version is not like above – you did not follow correctly the extraction process in step 2)	See Settings (Picture on first page of this instruction)
APP M1421-1151-190125OA	
MCU N8_05_20171012_01	
[Optional] DAB FW 56217207489	Enter DAB click on Settings (Gearwheel Icon in far left bottom corner).Compare the version information at left side bottom line.

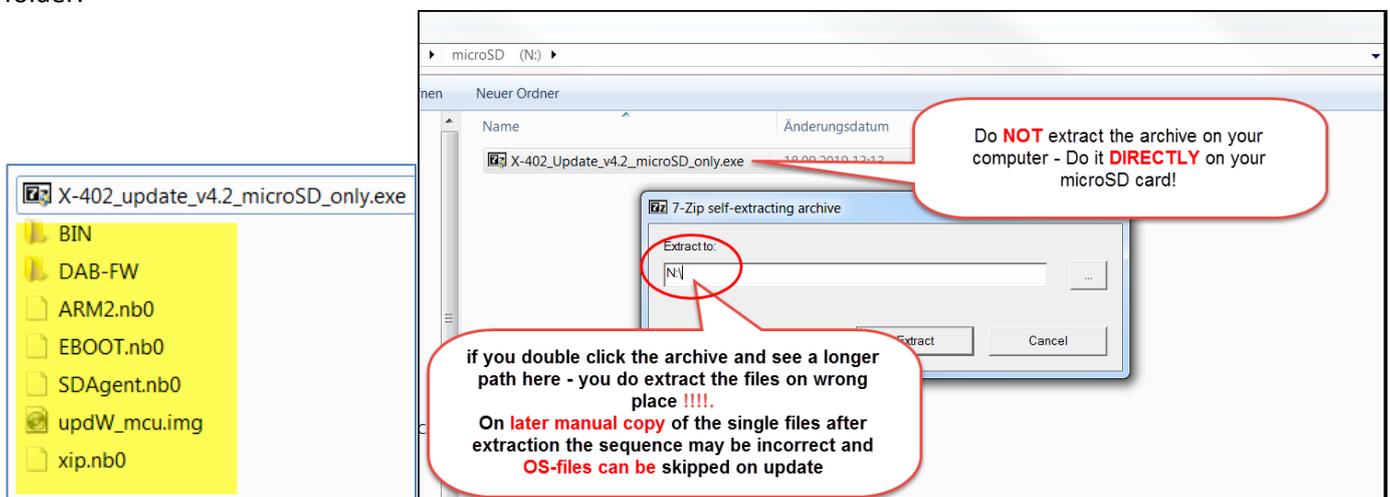
- 1) Download v4.2 SW files from our website >>X-402_Update_v4.2_microSD_only.exe<< (self-extracting archive). Browsers may prompt a warning which should be ignored in this case. **Don't abuse the original NavSW card**.
- 2) Copy the >>X-402_Update_v4.2_microSD_only.exe<< to **your empty microSD** card (top level/root) and extract the archive by double click or use context menu „extract here...“. After extracting, you should receive following files and folder:

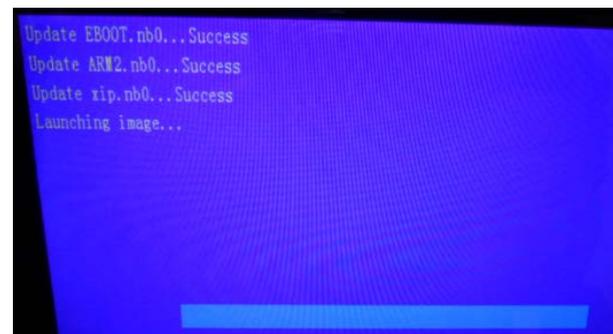
- 3) **Auto Step 1 OS (Please do NOT power off while the system shows a write/copy action on screen!)**

Please ensure your XZENT device is powered OFF. Insert your microSD card with the update files to the microSD port. Power ON your device. A blue OS update screen appears and will update EBOOT, ARM2 and XIP with a SUCCESS notification. A progressbar will show the overall progress and will start >>Launching image...<< when 100% is reached (see picture). After a short while it will switch automatically to the black APP and MCU update style screen.

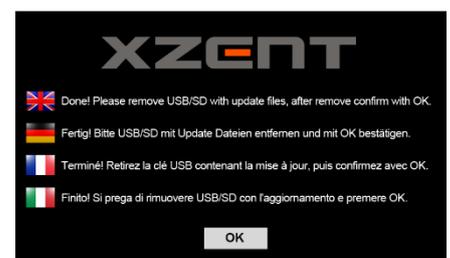
- 5) **Auto Step 3 MCU (Please do NOT power off while the system shows a write/copy action on screen!):**

When switching from Auto step 2 to Auto Step 3 it will start MCU update. The progress bar increases without displaying multiple files. When the progress bar reaches 100% it will show the END screen, asking to remove the update data carrier and then confirming the removal with OK button.

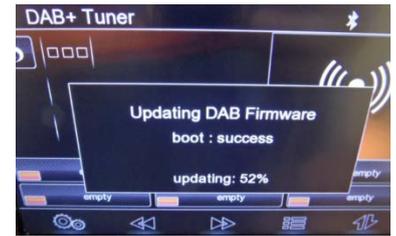
If the data carrier is detected it will show an update pop up (see picture).

Please wait until the **progress reaches 100%**, after a short while the pop up will close automatically

Do now compare and verify your software version.
